The University of Iowa sustained unprecedented damage in the 2008 flood. Design Engineers was selected as mechanical/electrical consultants for flood recovery and mitigation for ten out of fourteen buildings. The following two pages provide an overview of these projects. All projects required extensive coordination with FEMA personnel and procedures.

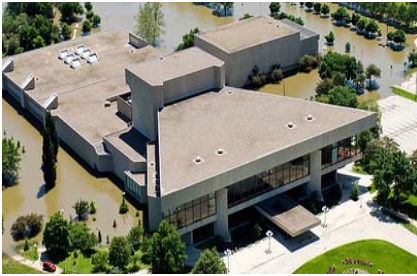
Hancher Auditorium – 134,000 sq-ft

- Damage: Water 18" above main level, lower level entirely submerged.
- Recovery: Temporary recovery of electrical service for stabilization of building completed.
- Mitigation: Study evaluating \$34,000,000 mitigation project completed. Mitigation strategies included relocating all mechanical/electrical systems a minimum of 3 feet above high water mark, installation of floor barrier wall at building perimeter with high capacity pumping system. University has elected to pursue a new facility.

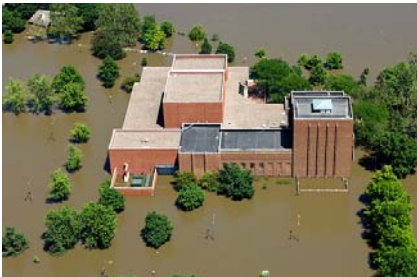
Voxman Music Building – 143,000 sq-ft

- Damage: Water 18" above main level, lower level entirely submerged.
- Recovery: Temporary recovery of electrical service for stabilization of building completed.
- Mitigation: Study evaluating \$36,000,000 mitigation project completed. Mitigation strategies included relocating all mechanical/electrical systems a minimum of 3 feet above high water mark, installation of floor barrier wall at building perimeter with high capacity pumping system. University has elected to pursue a new facility.

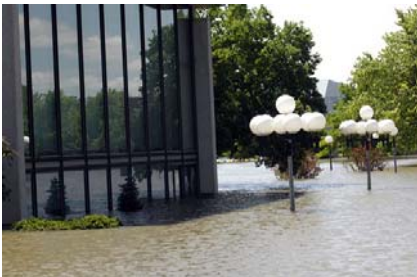
Clapp Auditorium – 39,000 sq-ft

- Damage: Water 4 ft above main level.
- Recovery: Temporary recovery of electrical service for stabilization of building completed.
- Mitigation: Study evaluating \$10,000,000 mitigation project completed. Mitigation strategies included relocating all mechanical/electrical systems a minimum of 3 feet above high water mark, installation of floor barrier wall at building perimeter with high capacity pumping system. University has elected to pursue a new facility.

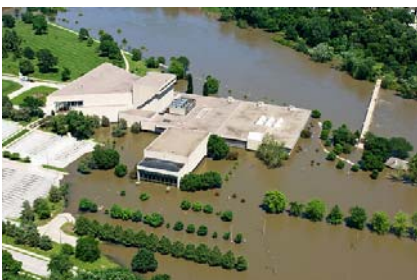
Theatre Building – 85,000 sq-ft

- Damage: Lower level entirely submerged.
- Recovery: Temporary recovery completed of building systems (\$3,100,000). Main and upper levels reoccupied, lower level unoccupied.
- Mitigation: Planning and design underway for \$18,500,000 mitigation project. Mitigation strategies include relocating all mechanical/electrical systems a minimum of 3 feet above high water mark, installation of floor barrier wall at building perimeter with high capacity pumping system.

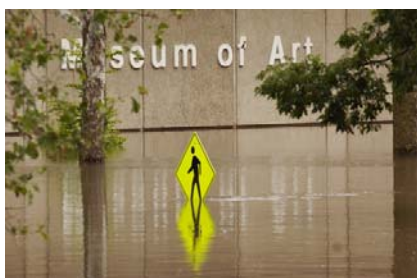
Museum of Art – 67,000 sq-ft

- Damage: Water level 2 ft above main floor, lower level entirely submerged.
- Recovery: Temporary recovery completed of building systems to allow partial reoccupancy of building for temporary accommodation of Music
- Mitigation: Planning and evaluation underway. Mitigation strategies include relocating all mechanical/electrical systems a minimum of 3 feet above high water mark, installation of floor barrier wall at building perimeter with high capacity pumping system.

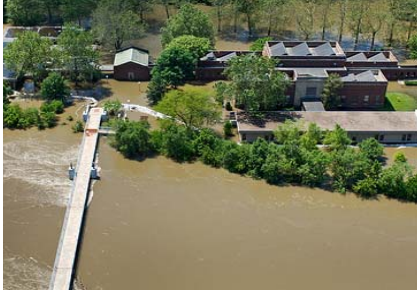
Art Building – 92,000 sq-ft

- Damage: Water 2 ft above main level, lower level entirely submerged.
- Recovery: Temporary recovery of electrical service for stabilization of building completed.
- Mitigation: Study evaluating mitigation options completed. Mitigation strategies included relocating all mechanical/electrical systems a minimum of 3 feet above high water mark, installation of floor barrier wall at building perimeter with high capacity pumping system. University has elected to pursue a new facility.

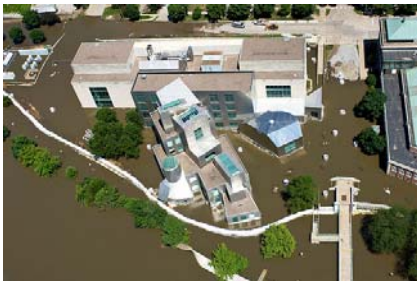
Iowa Advanced Technology Laboratories – 136,000 sq-ft

- Damage: Water level 2.5 ft above main floor, lower level entirely submerged.
- Recovery: Temporary recovery completed of building systems (\$2,000,000). Building is reoccupied.
- Mitigation: Planning and design underway for \$22,000,000 mitigation project. Mitigation strategies include relocating all mechanical/electrical systems a minimum of 3 feet above high water mark, installation of floor barrier wall at building perimeter with high capacity pumping system.

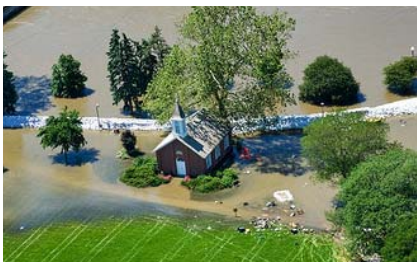
Danforth Chapel – 1,000 sq-ft

- Damage: Water level 2 ft above main floor, crawl space entirely submerged.
- Recovery: Recovery completed (\$70,000). Building is reoccupied.
- Mitigation: No work to date.

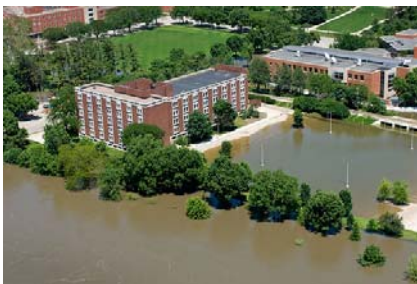
English Philosophy Building – 88,000 sq-ft

- Damage: Water level 2 ft above main floor, lower level entirely submerged.
- Recovery: Temporary recovery completed of building systems and lower level (\$900,000). Building is reoccupied.
- Mitigation: Planning and evaluation is underway. Mitigation strategies include relocating all mechanical/electrical systems a minimum of 3 feet above high water mark, installation of floor barrier wall at building perimeter with high capacity pumping system.

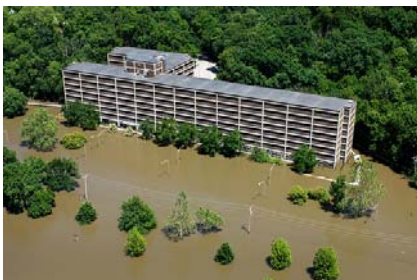
Mayflower Residence Hall – 248,000 sq-ft

- Damage: Water level 2.5 ft above main floor, lower level entirely submerged.
- Recovery: Temporary recovery completed of building systems (\$1,700,000). Building is reoccupied.
- Mitigation: Planning and evaluation is underway. Mitigation strategies include relocating all mechanical/electrical systems a minimum of 3 feet above high water mark, installation of floor barrier wall at building perimeter with high capacity pumping system.
